Miscellaneous Paper CERC-96-3
May 1996

Physical Model Study of Breakwater Stability, Kodiak, Alaska

Prepared for U.S. Army Engineer District, Alaska

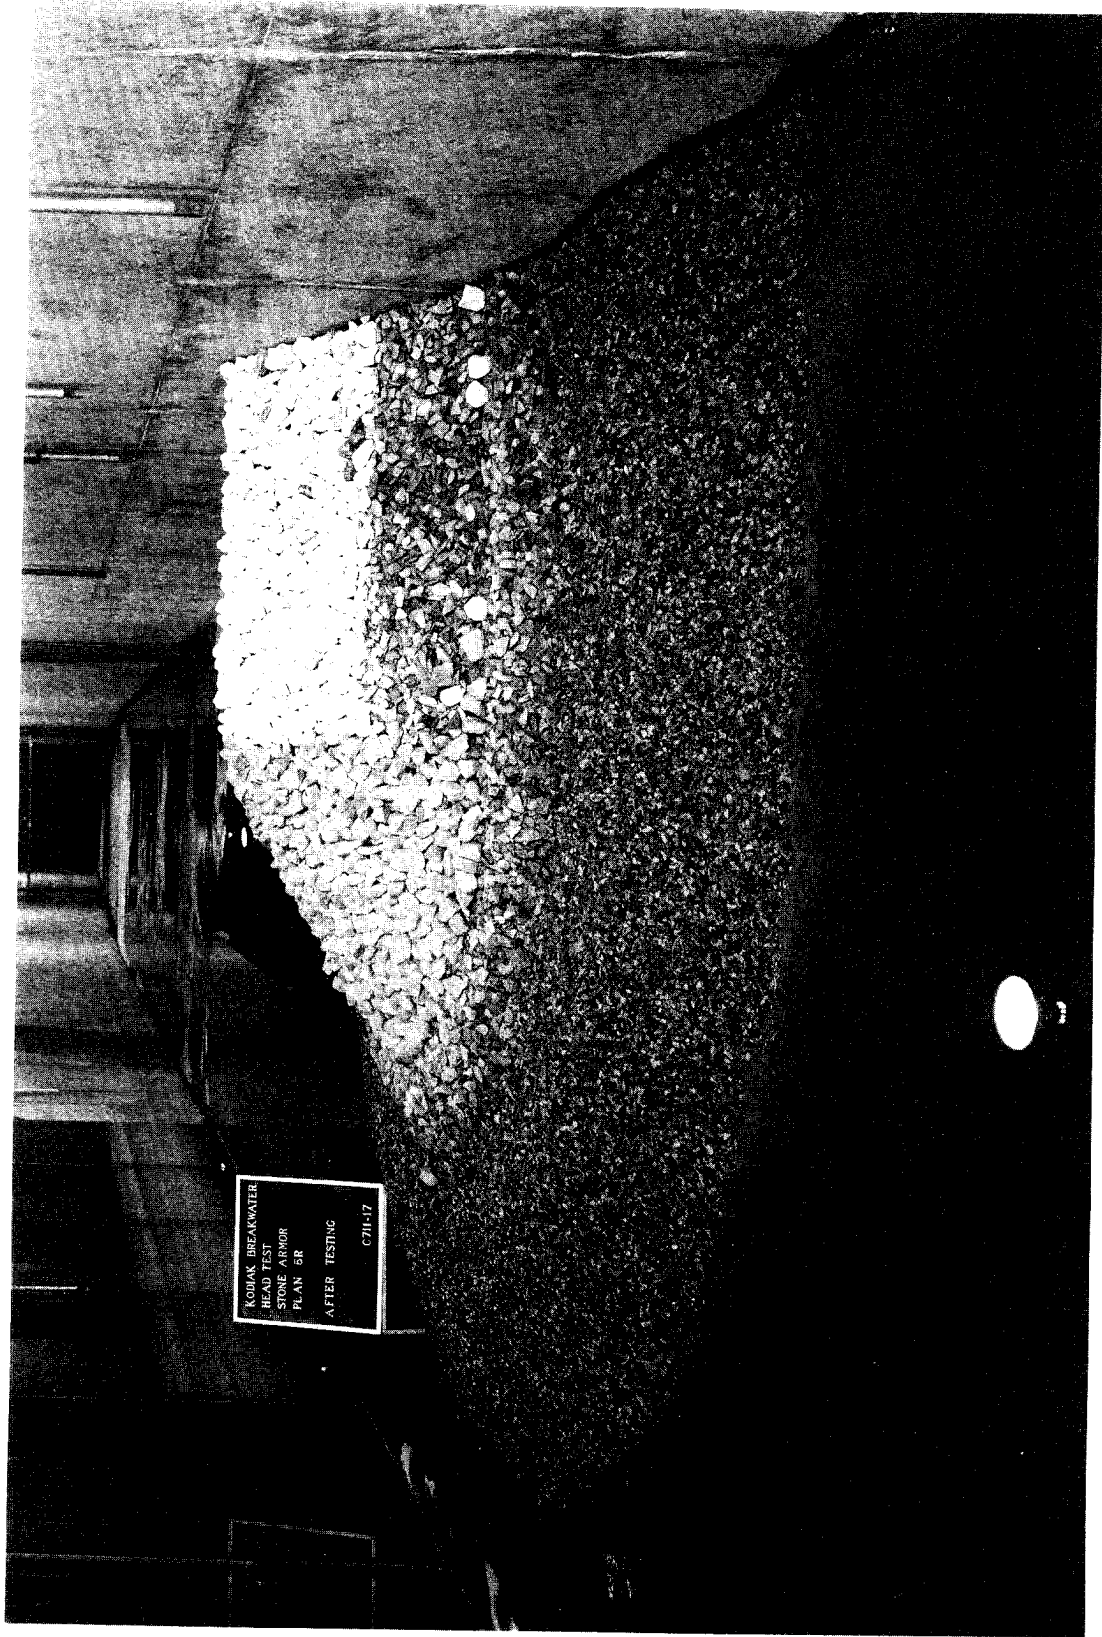
Photo 28. Harbor-side view of model breakwater Plan 5R after testing

The final three test runs of the St. Herman Harbor stability test series were conducted at swl = 0.0 m (0.0 ft) mllw with $T_p = 14$ sec and $H_{m0} = 1.7$ m (5.5 ft). Each of the last three runs was of 48-min duration. Three additional stones were lost from the scour hole on the sea-side trunk with minor additional damage observed elsewhere on the structure. No damage was detected on the structure toe or consolidation pad. Photos 26, 27, and 28 show the sea side, end view, and harbor side, respectively, of Plan 5R after testing.
